Model Q34 (1947-1948)

RCA Radio Corporation of America

Restoration

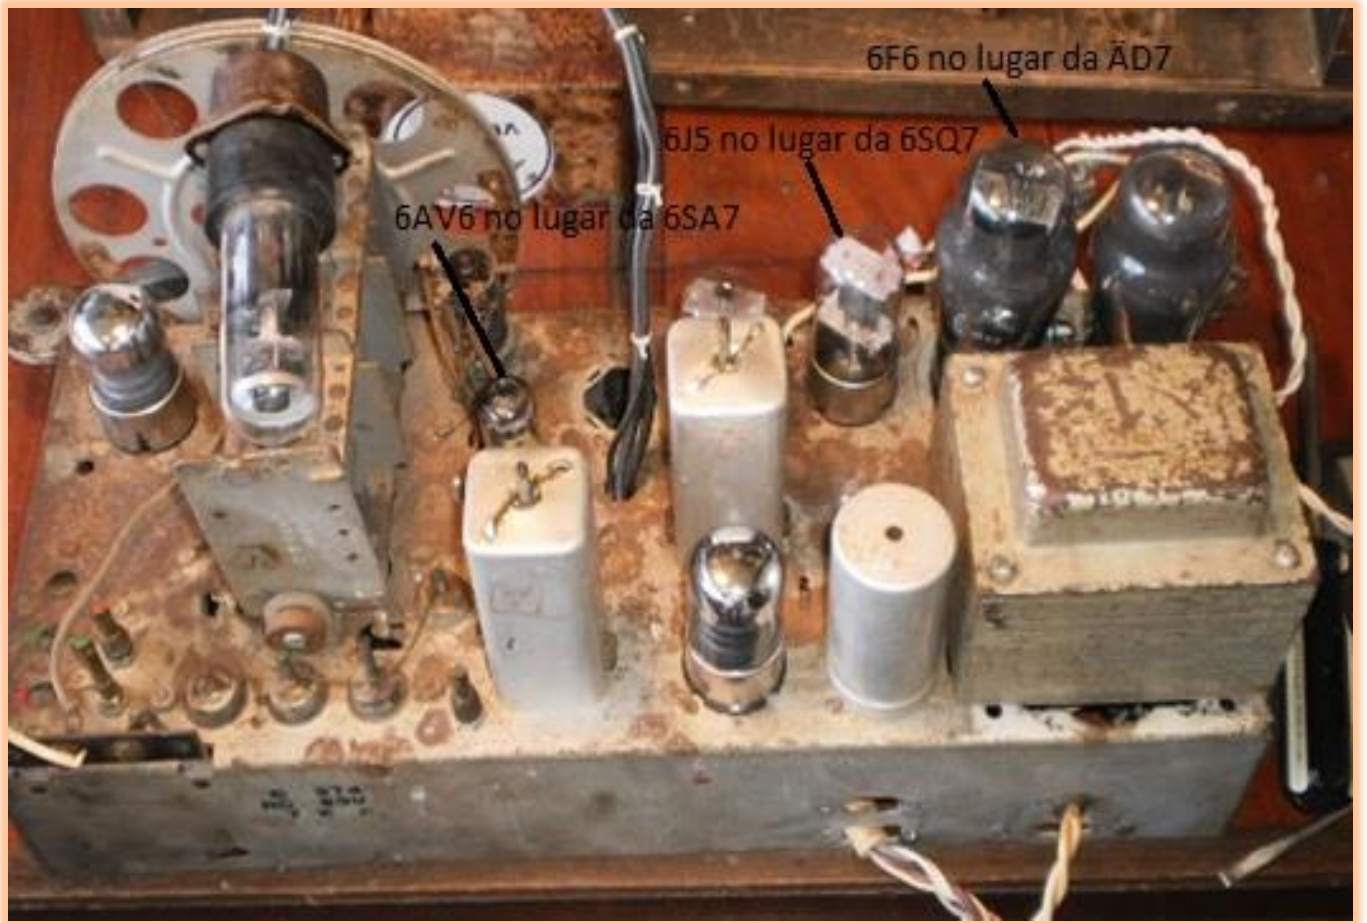
The Q34 RCA uses the push-pull one 6AD7 tube as a 6F6 tube. The 6AD7 also acts with driver tube. In assembly received in place of 6AD7 was another 6F6 and as driver was used a 6J5 valve. It was also incorrect valve, which operates as oscillator and mixer: instead of the original 6SA7, one 6BE6 valve was placed and connected with wires to the base.

The chassis as received with non-original valves.

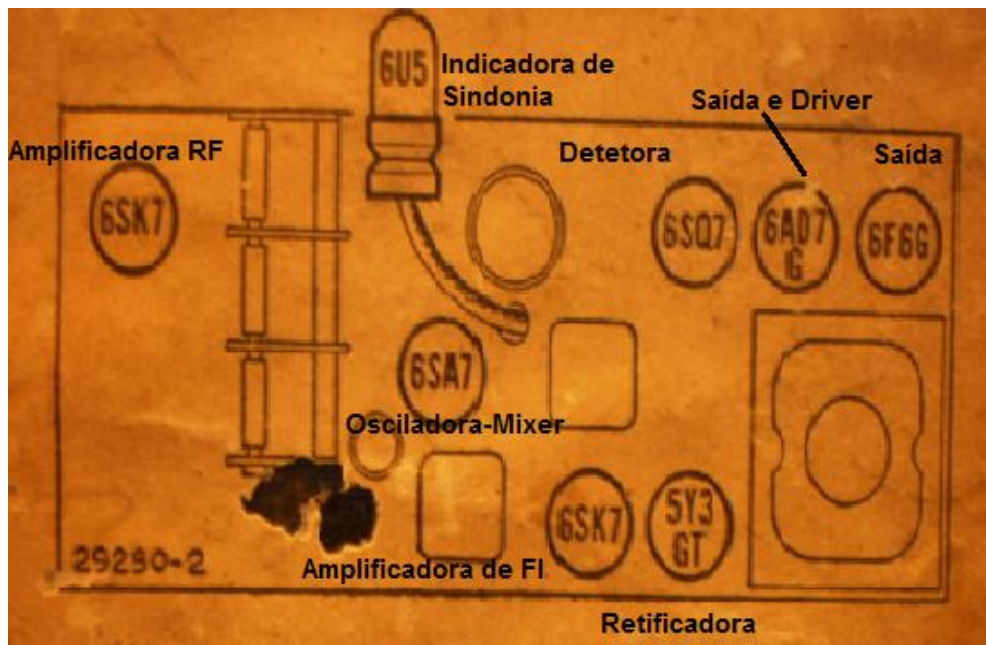
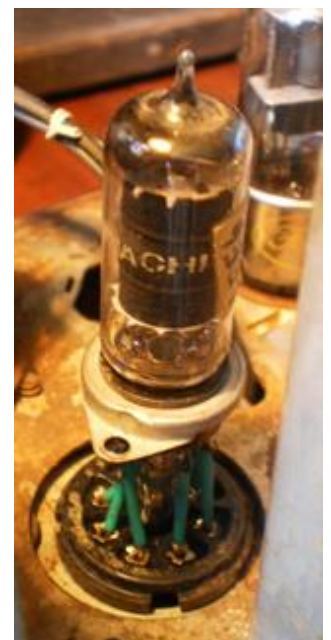
Left the original scheme of valves and right exotic 6BE6 valve connected with an adaptation by wires to the base of the original 6SA7.

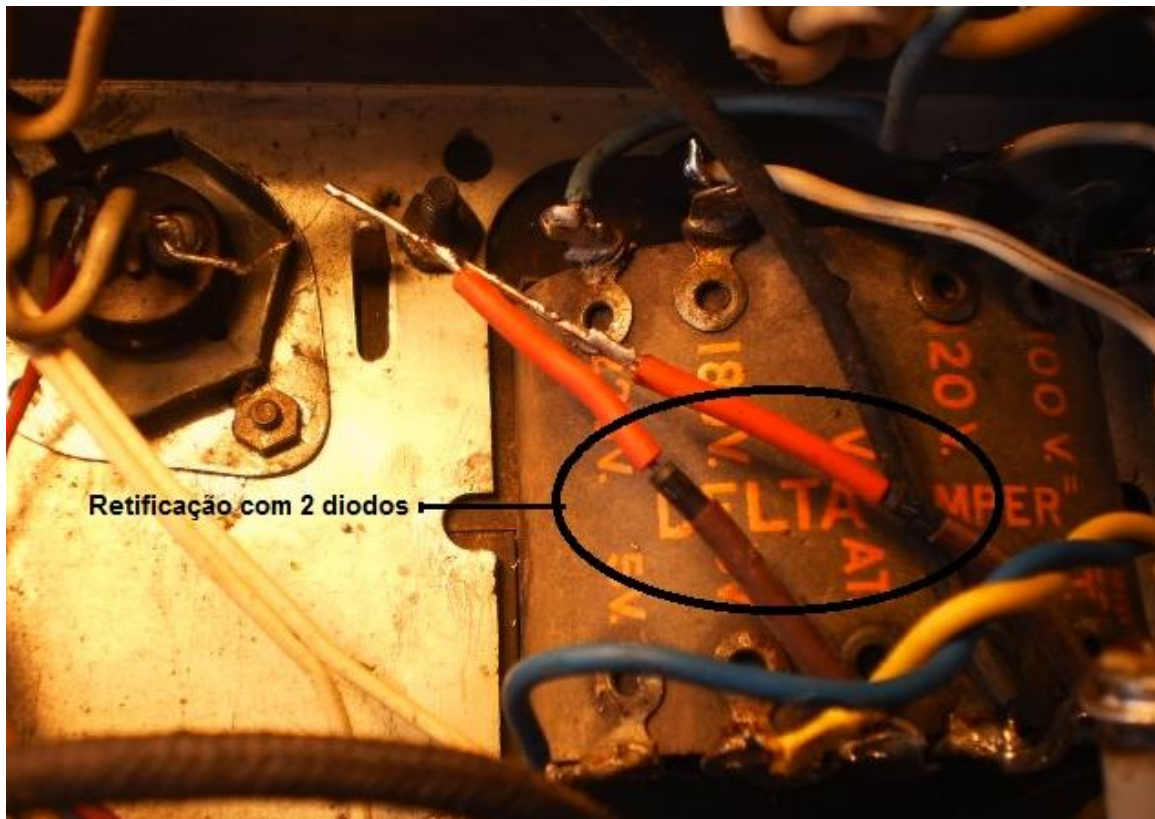
In the photo, the use of two rectifier diodes connected to the high-voltage input transformer.

Beginning the restoration I always start providing the rectified voltage operation, called B + (VCC), which resulted in the placement of a basis for 5Y3 rectifier valve and its high-voltage and filament connections. Although I received the radio with rectifying diode, luckily, the input transformer had 5 VAC outputs to feed the filaments of the rectifier valve 5Y3, the original rectifier tube in the scheme. In follow-up, arranged one electrodynamic speaker to serve as a filter shock to the + B. Unfortunately, I only had a circular AF: it is rare of finding an electrodynamic and oval speaker.

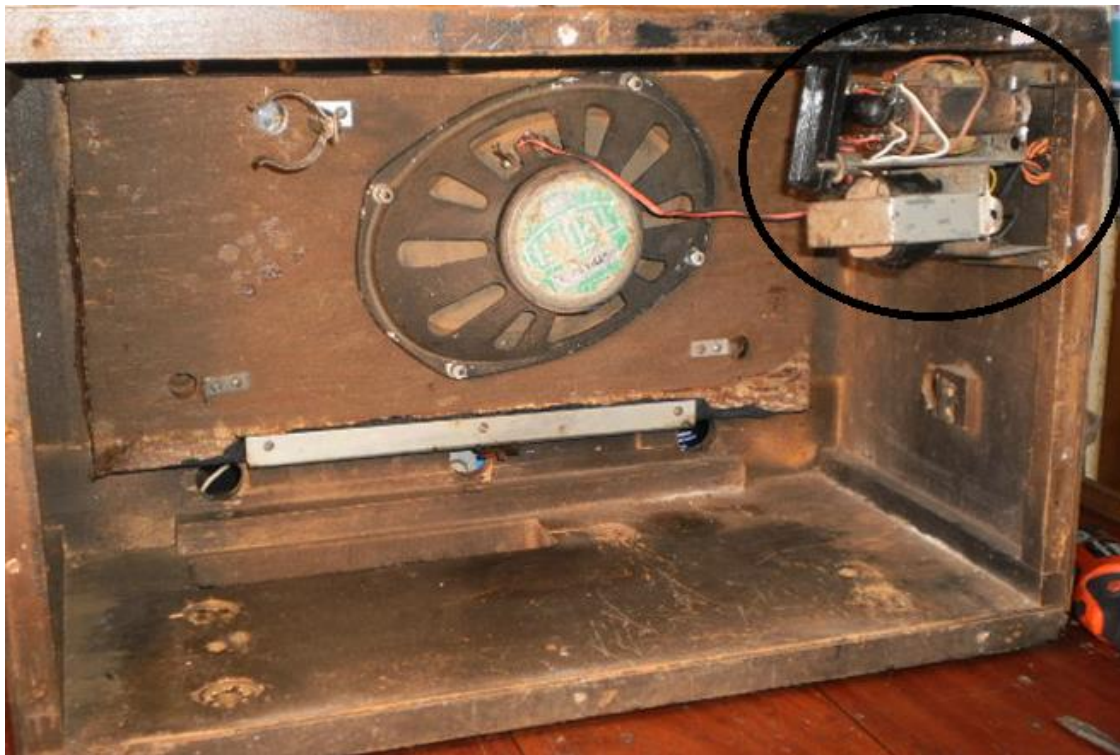
The output push-pull transformer and a shock were screwed in the upper right corner of the back of the box, as pictured below. On the other hand, the original speaker of the RCA Q34 is a rare type of oval shape and electrodynamic operation. Not getting this piece, the former owner used an oval AF, but with permanent magnet. It requires a big filter shock, which held the wood, in side the push-pull transformer.

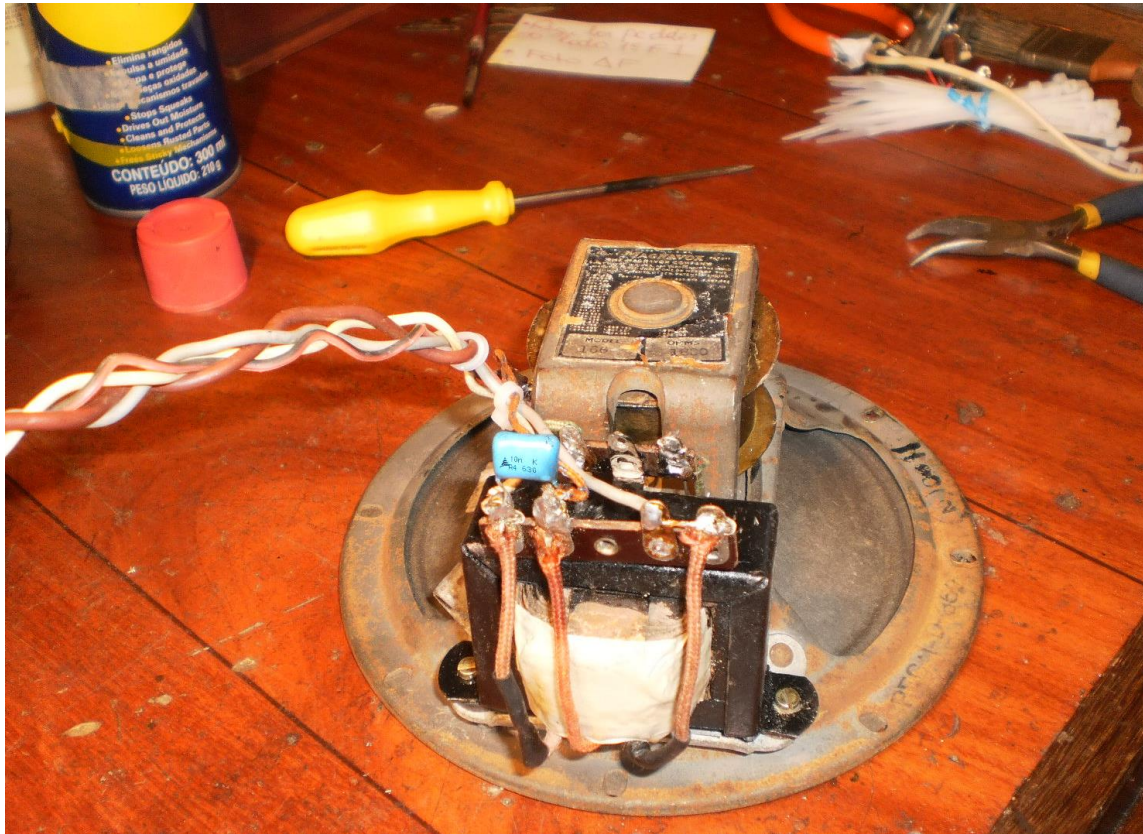
A new push-pull transformer was mounted in the speaker with twisted wires to the two plates (6F6 and 6AD7), the cathode connection of the rectifier valve and the return of + B (pictured below).

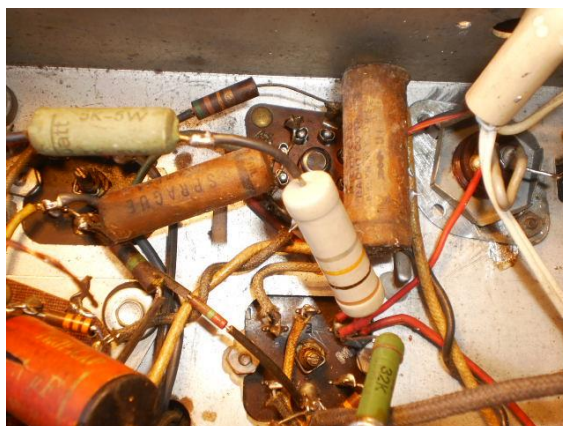
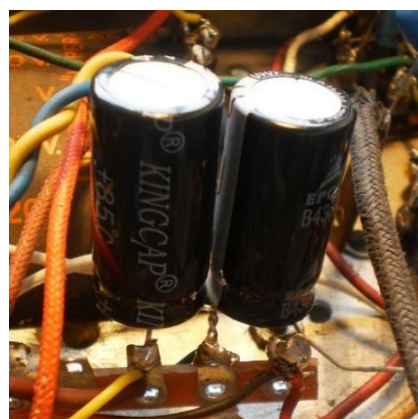
After I mounted two electrolytic capacitors 47 microfarads x 450V each and redone all longstanding and continuous distribution of B + voltage. The other defective capacitors were replaced. In the photos below, one aspect of the common old capacitors and two new electrolyte.

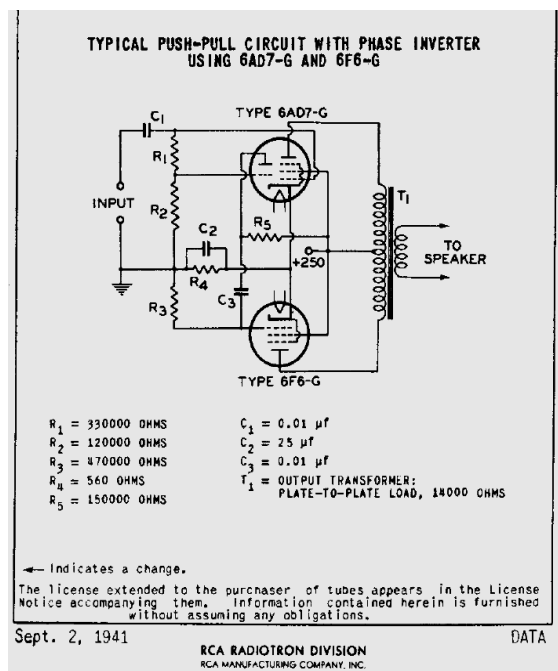
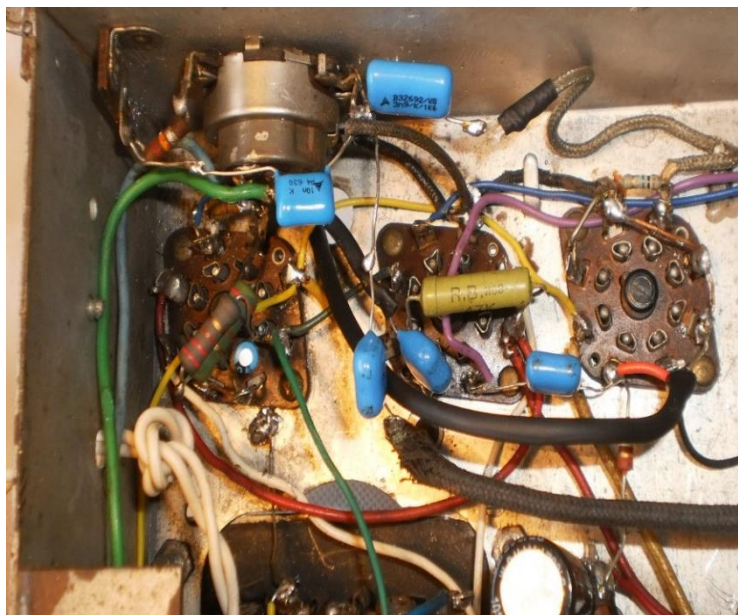
The original RCA scheme (left), very clarified assembly. It operates with its left part (triode) as a phase inverter (drive). On right (heptodo) as output valve, such as 6F6. In the image at the right, it is assembled ready and working with the 6AD7 between 6F6 and 6SQ7 (detector tube).

As courtesy of partner Sergio Caon, I installed the 6AD7 valve. It has two functions; it acts as "driver" and as push-pull output.

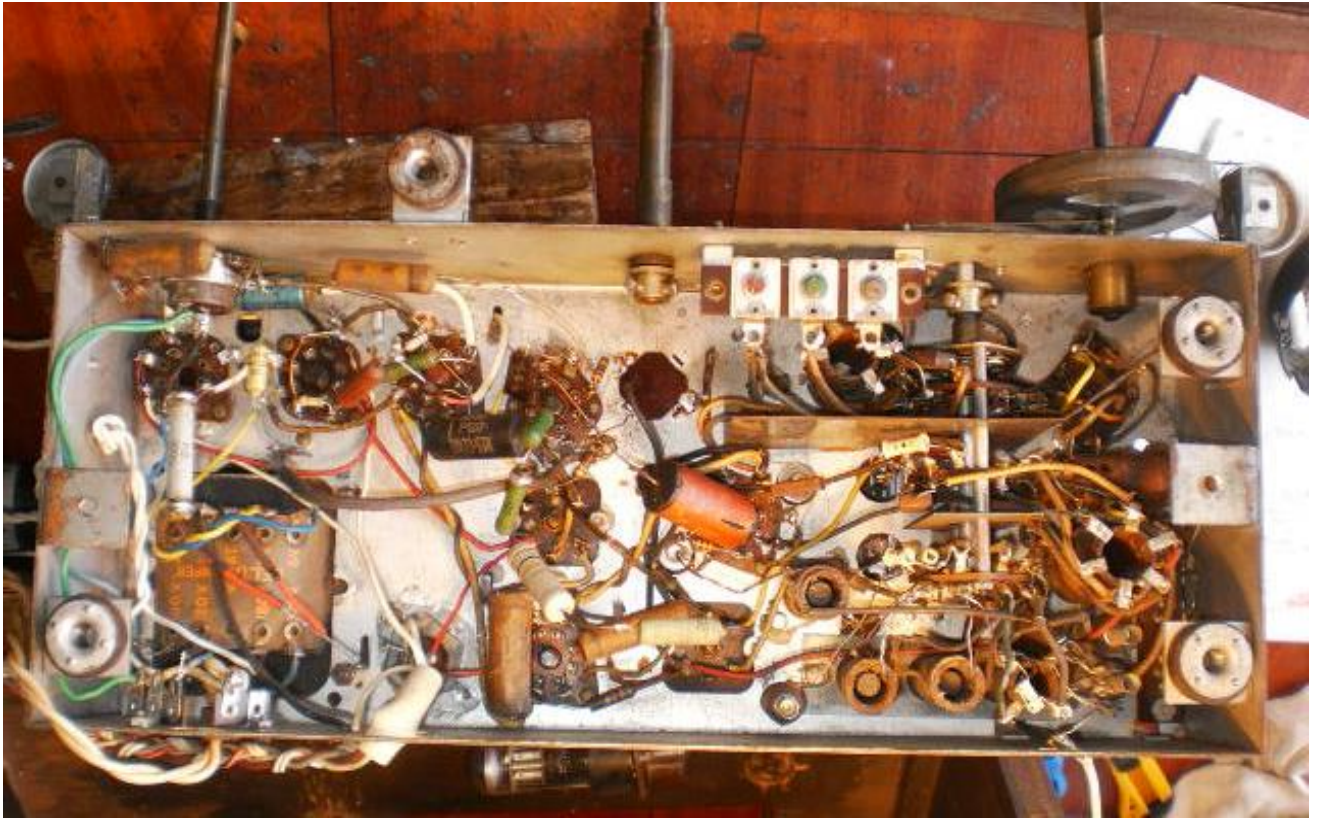
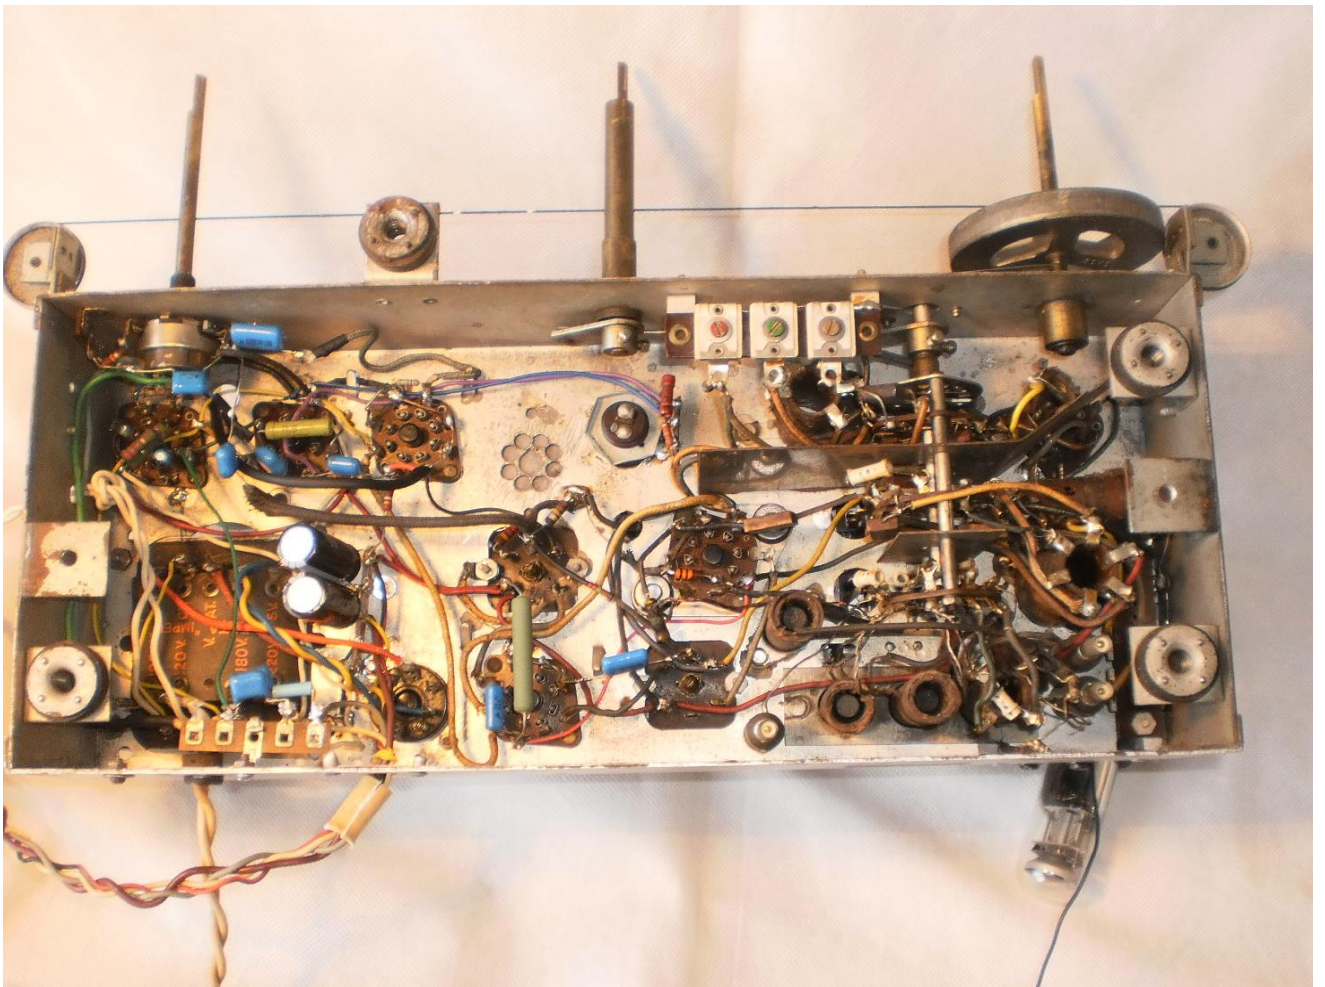
The following figures show how the circuit was received before and after the electronic restoration:

The circuit was received with capacitors "tired" and some inadequate resistance. After replaced the correct tubes and the capacitors, it was time to check the tensions, with the placement of new resistance, leaving the ratings shown in the table below:

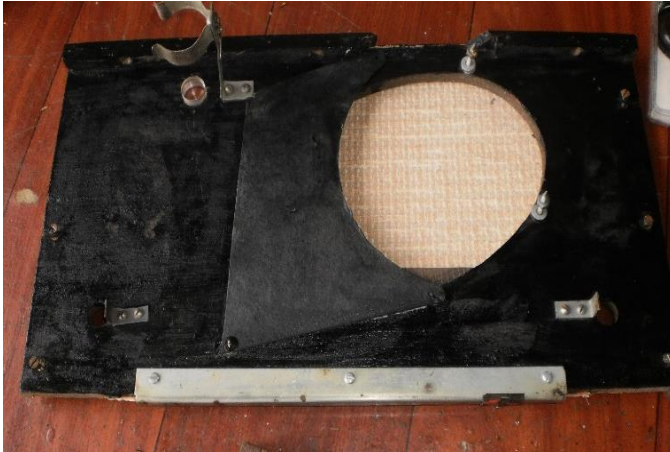
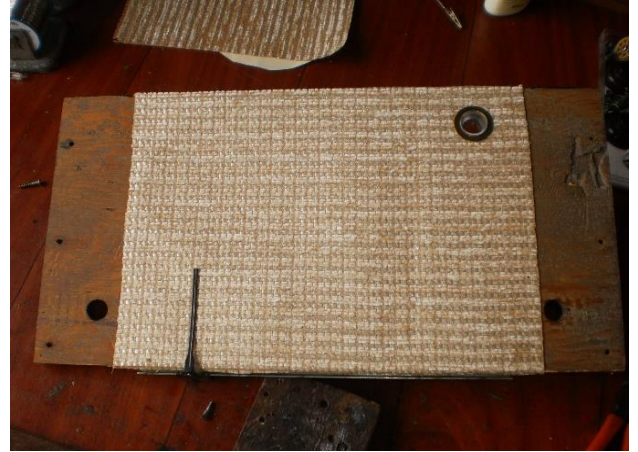
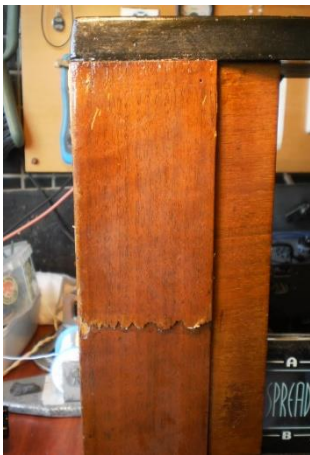
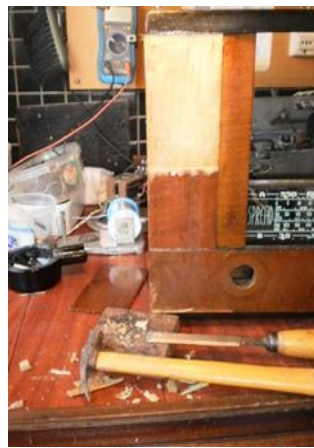
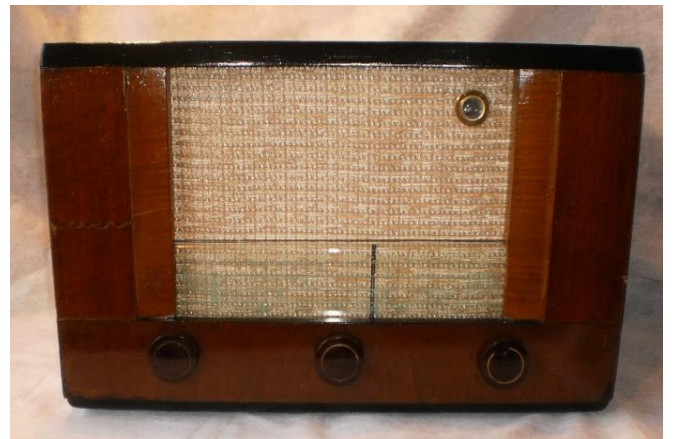
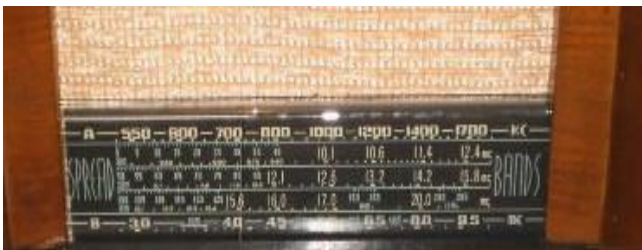
Before the cloth, I had to hit the hole timber, because the Q34 receiver used an elliptical AF. With the indispensable help of Helena Halushuk, to adjust the AF support plank to a circular design and fix the tissue. In the radio's cabinet there was a crack, which was restored. Better than words are the photos:

Right above, the job is done. The following was placed at the bottom and on the fabric, a black cardboard strip to make the highlight of the dial on the fabric (pictured left).

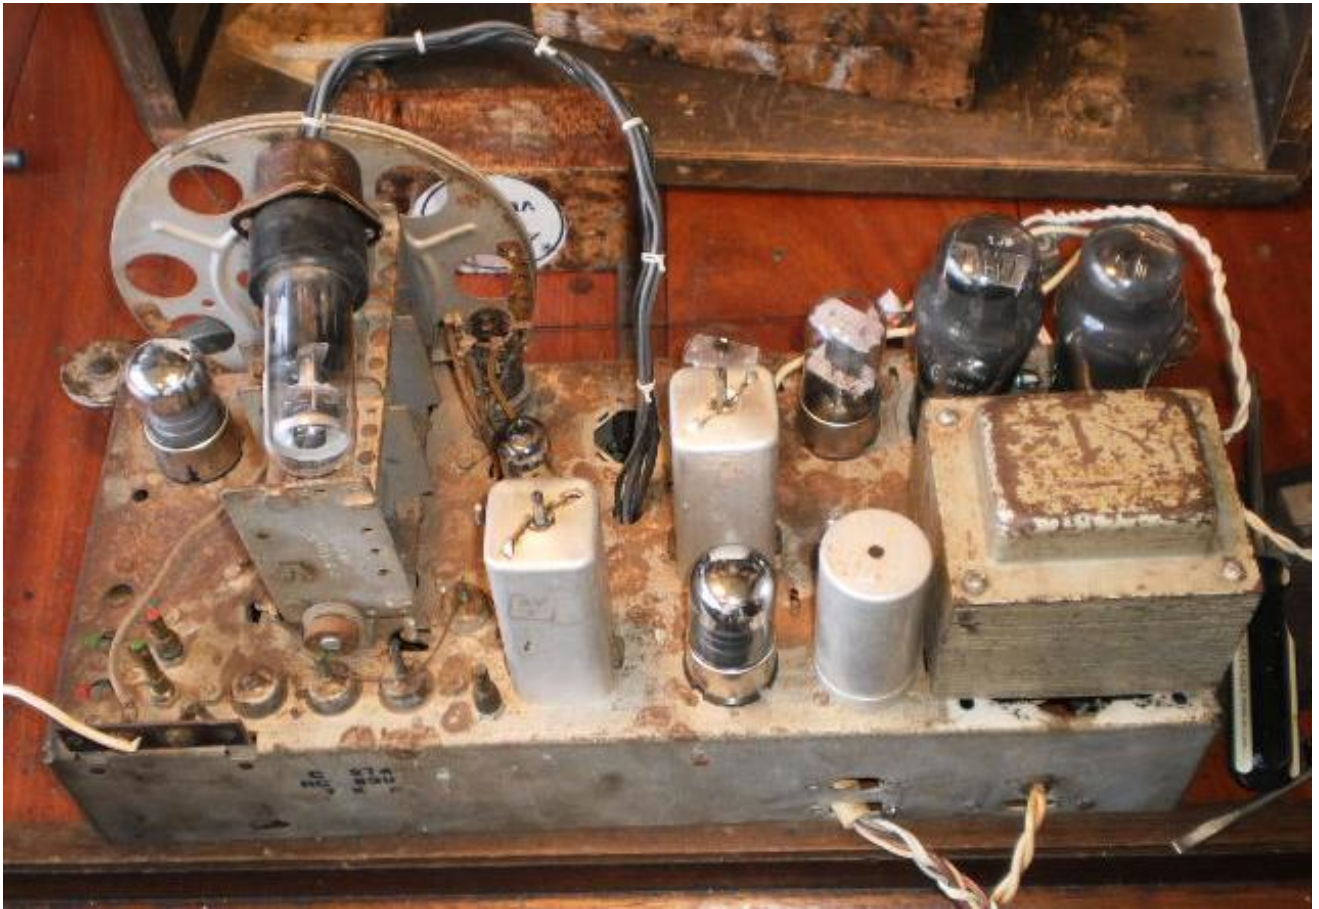
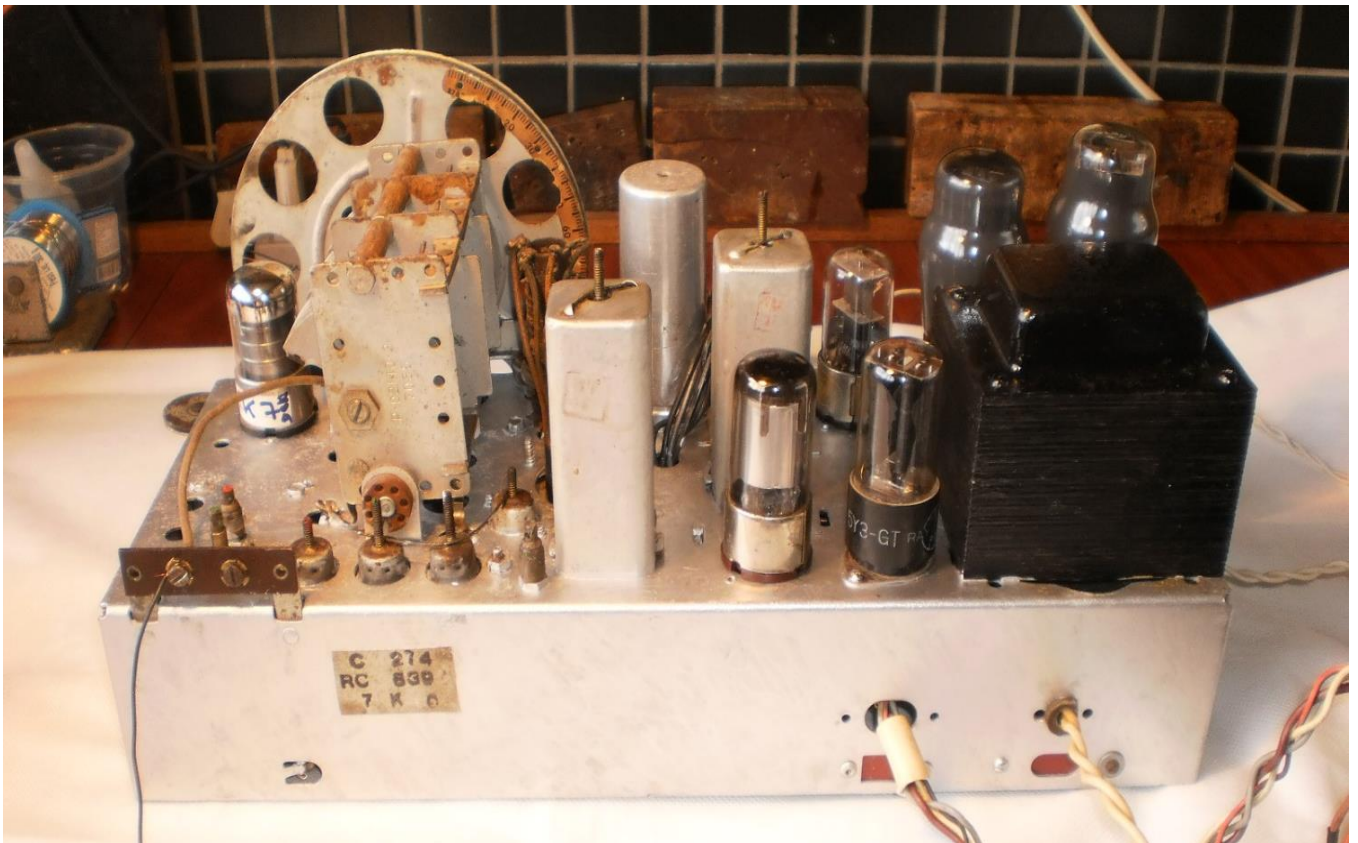
Lots of cleaning with brush and thinner and two hands automotive lacquer.

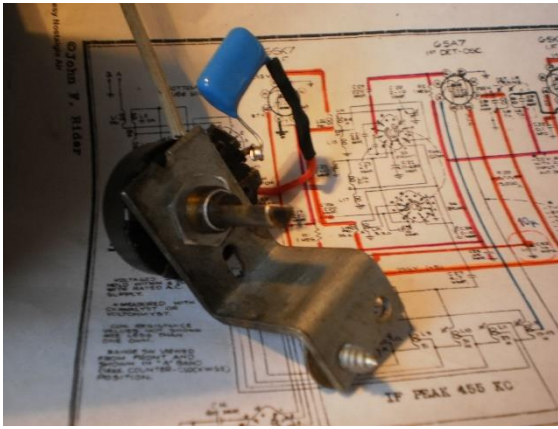
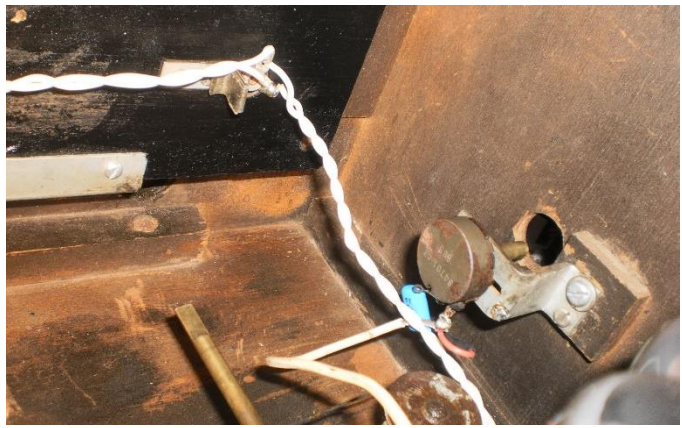
Above, tone control of the restoration of photos, with internal cleansing pot and capacitor replacement.
